Slope Stability in Road Construction

SLOPE STABILITY IN ROAD CONSTRUCTION^x

A GUIDE TO THE CONSTRUCTION OF STABLE ROADS IN WESTERN OREGON AND NORTHERN CALIFORNIA

1976

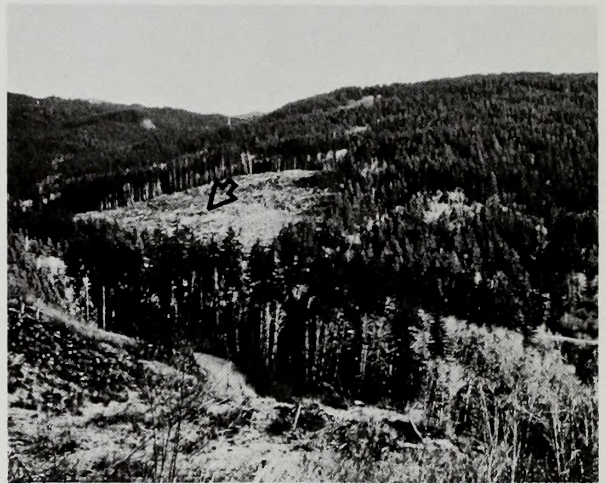
Figure 68. Terrain derived from the weathered siltstone of the Nestucca Formation. Note the hummocky slopes, the large slump in the clearcut area (arrow), and the hydrophytes at the right of the photo.

The Nestucca Formation contains considerable siltstone and the stability problem originates in the siltstone that is basically incompetent and easily weathered. Slumps and earthflows, both large and small, are very common when this material is subjected to heavy winter rainfall (as much as 100 inches in the Nestucca River basin). The landscape may exhibit a benchy or hummocky appearance. Slopes with gradients as low as 24 percent may be considered to be unstable in deeply weathered siltstone with abundant water. Many of the higher ridges in the Nestucca Formation are composed of intrusive volcanic rock and the siltstone forms the easily eroded basins bounded by the harder material. Bear Creek drainage, a tributary of the Nestucca River, contains examples of these stability problems (Figure 68).

Vegetative and topographic indicators of slope instability are numerous. Large patches of alder, maple, or other hydrophytes¹ indicate high ground water levels and impeded drainage (see the large patch of alder and big leaf maple in Figure 68). Conifers may be caused to tip or lean by earthflow or soil creep. Slumps cause numerous benches, some of which show sag ponds. Blocks of soils may sag and leave large

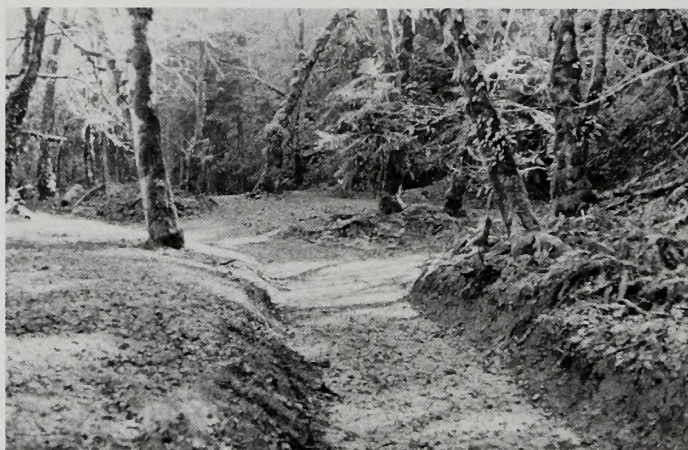
Figure 70. Ditches can be used to drain sag ponds and depressions.

a series of tractor excavated ditches as shown in Figure 70.

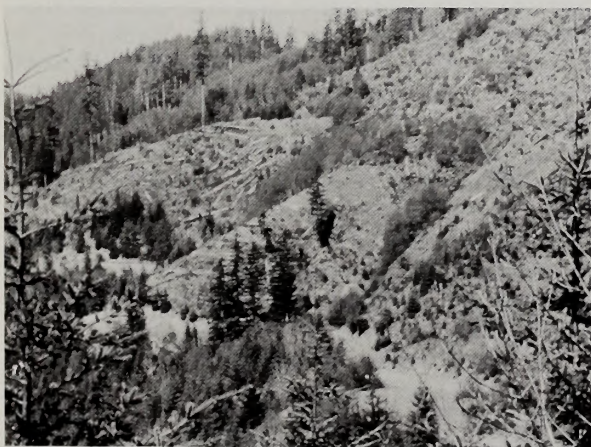
Figure 72. Small sandstone ridgenoses on a slope of igneous rock.

Note the alder which outlines the contact zone at B. Figure 72 shows a ground view of this indicator of ground water accumulation. The large spur ridge at C may be relatively stable because of the large mass of material involved, and stability problems may be confined to the immediate contact zone (Figure 73). The arrow above A in Figure 71 indicates the location of a debris avalanche which occurred since these photos were taken.

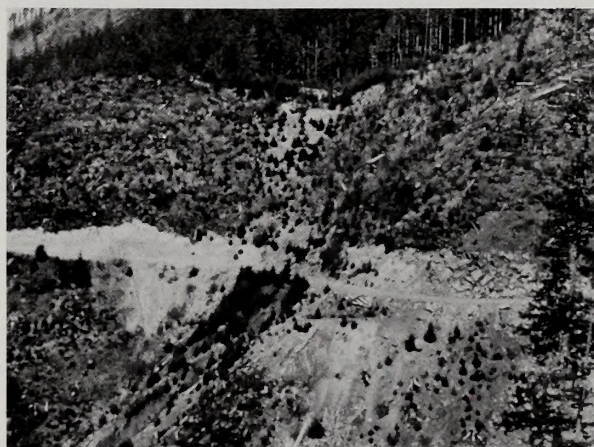
Figure 73. Contact zone between sandstone (left) and igneous rock (right).

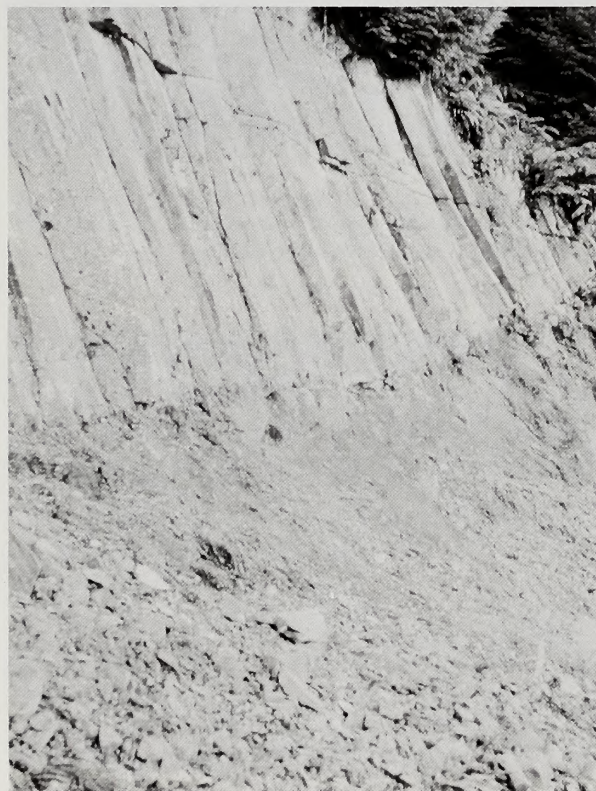
Figure 74. Red breccia (bottom) overlain by basalt.

The extrusive igneous rocks (basalt and andesite) are often interbedded with pyroclastic rock (Figure 74); therefore, the slope stability problems of the extrusive igneous rocks and the pyroclastics overlap and will be considered together.

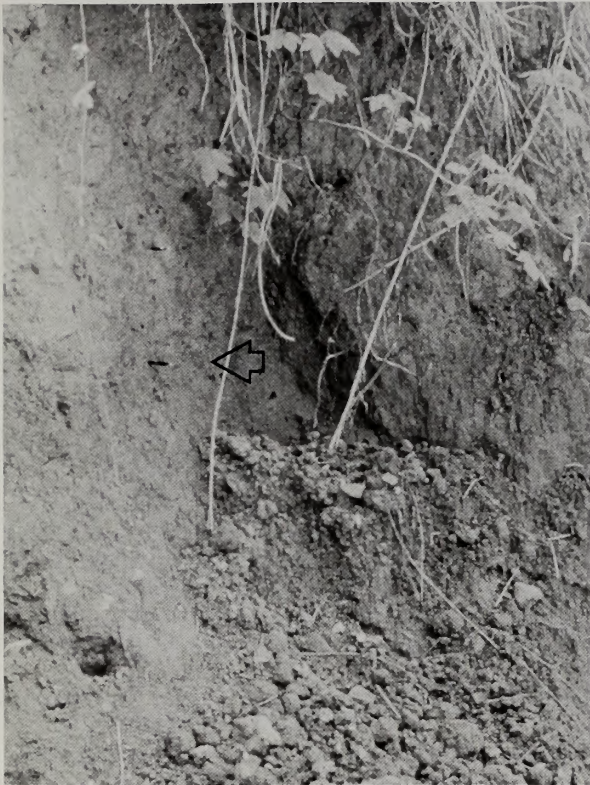
Figure 75. The arrow shows a buried soil layer; pencils show springs.

Extrusive igneous rocks generally provide better road building material than the bedded sediments. While the rock itself may be quite stable, the material may weather into deep soils with a potential for slumps and earthflows. The upper slopes are frequently steep with shallow soils while the lower slopes usually have thick soil mantles as a result of erosion from the upper slopes together with deep weathering. Subsurface flow usually moves rapidly downslope through the thin soil mantle that overlies the impermeable bedrock. Much of this ground water appears as springs at the upslope side of benches that are common along the streams in this terrain. The remainder of the ground water seeps through the deep soils to the streams. Road cuts often expose soil layers buried as a result of ancient slope failures and ground water may move laterally along these layers and appear as springs in the cut face after road construction (Figure 75). These local wet spots are a frequent source of small slumps.

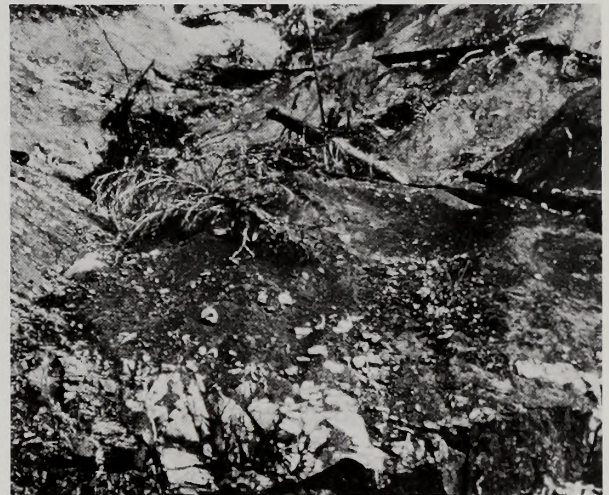
Figure 76. Pyroclastic materials overlying basalt

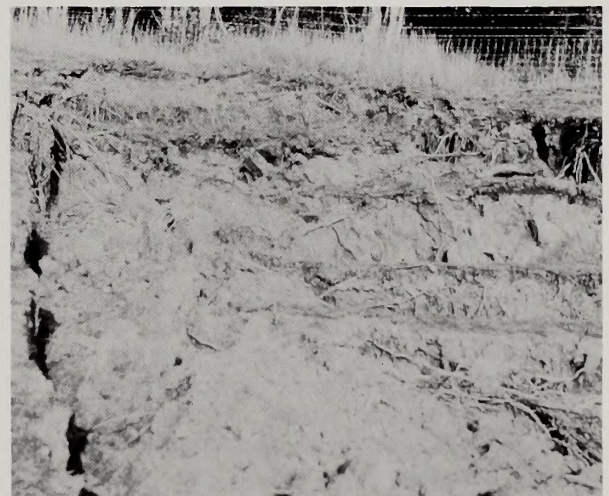
Figure 77. A progressive slump is a series of slope failures that may extend to the ridgetop.

causes failure of the next block of soil immediately upslope, and so forth, until there is a series of slumps one above the other that may extend to the top of the ridge (Figure 77). Ground water is usually abundant at these locations and engineers should be on the lookout for signs of an impending slope failure that could develop into a progressive slump.

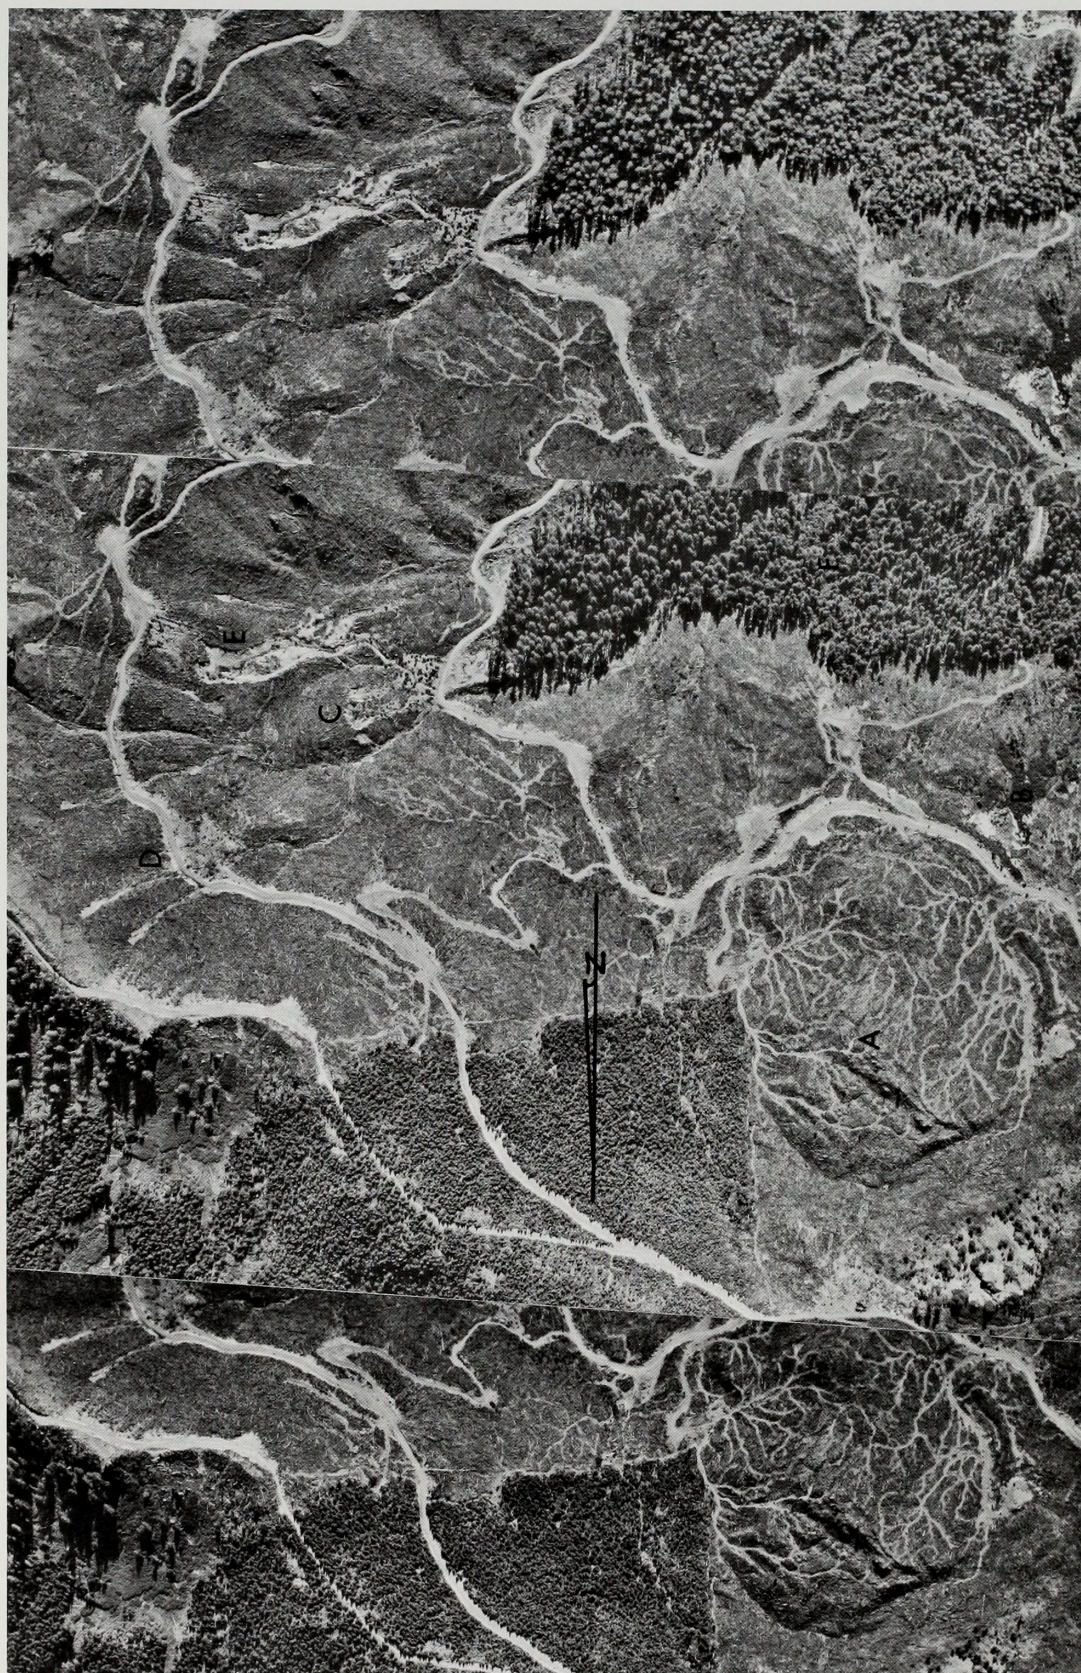
Figure 82. A stereogram of terrain developed from pyroclastics and capped by harder extrusive rock. The large, old slump at A appears to be covered with large pieces of cap rock. Other slumps, old and new, are found at points B to E. Note the hummocky landscape and the presence of hydrophytes at point F.

Figure 82 is a stereogram of a portion of upper Thomas Creek, a tributary of the South Santiam River southeast of Mill City, Oregon. This area has a thick layer of pyroclastics capped by extrusive rock. Note the large, circular mass that appears to have slumped away from the higher ridges. There appear to be remnants of the harder cap rock at the summit of the slump mass (point A). There are many other smaller slumps that have created the benchy, hummocky terrain typical of unstable portions of pyroclastic material. There are large slumps, old and new, at B, C, and D, and smaller slope failures near D and E. Note how many of these failures originate in clearcut areas and are not associated with roads. The mature timber in the lower part of the basin contains tipped and leaning trees. Note the large clumps of alder, a locally defined hydrophyte, in the lower drainage at F.

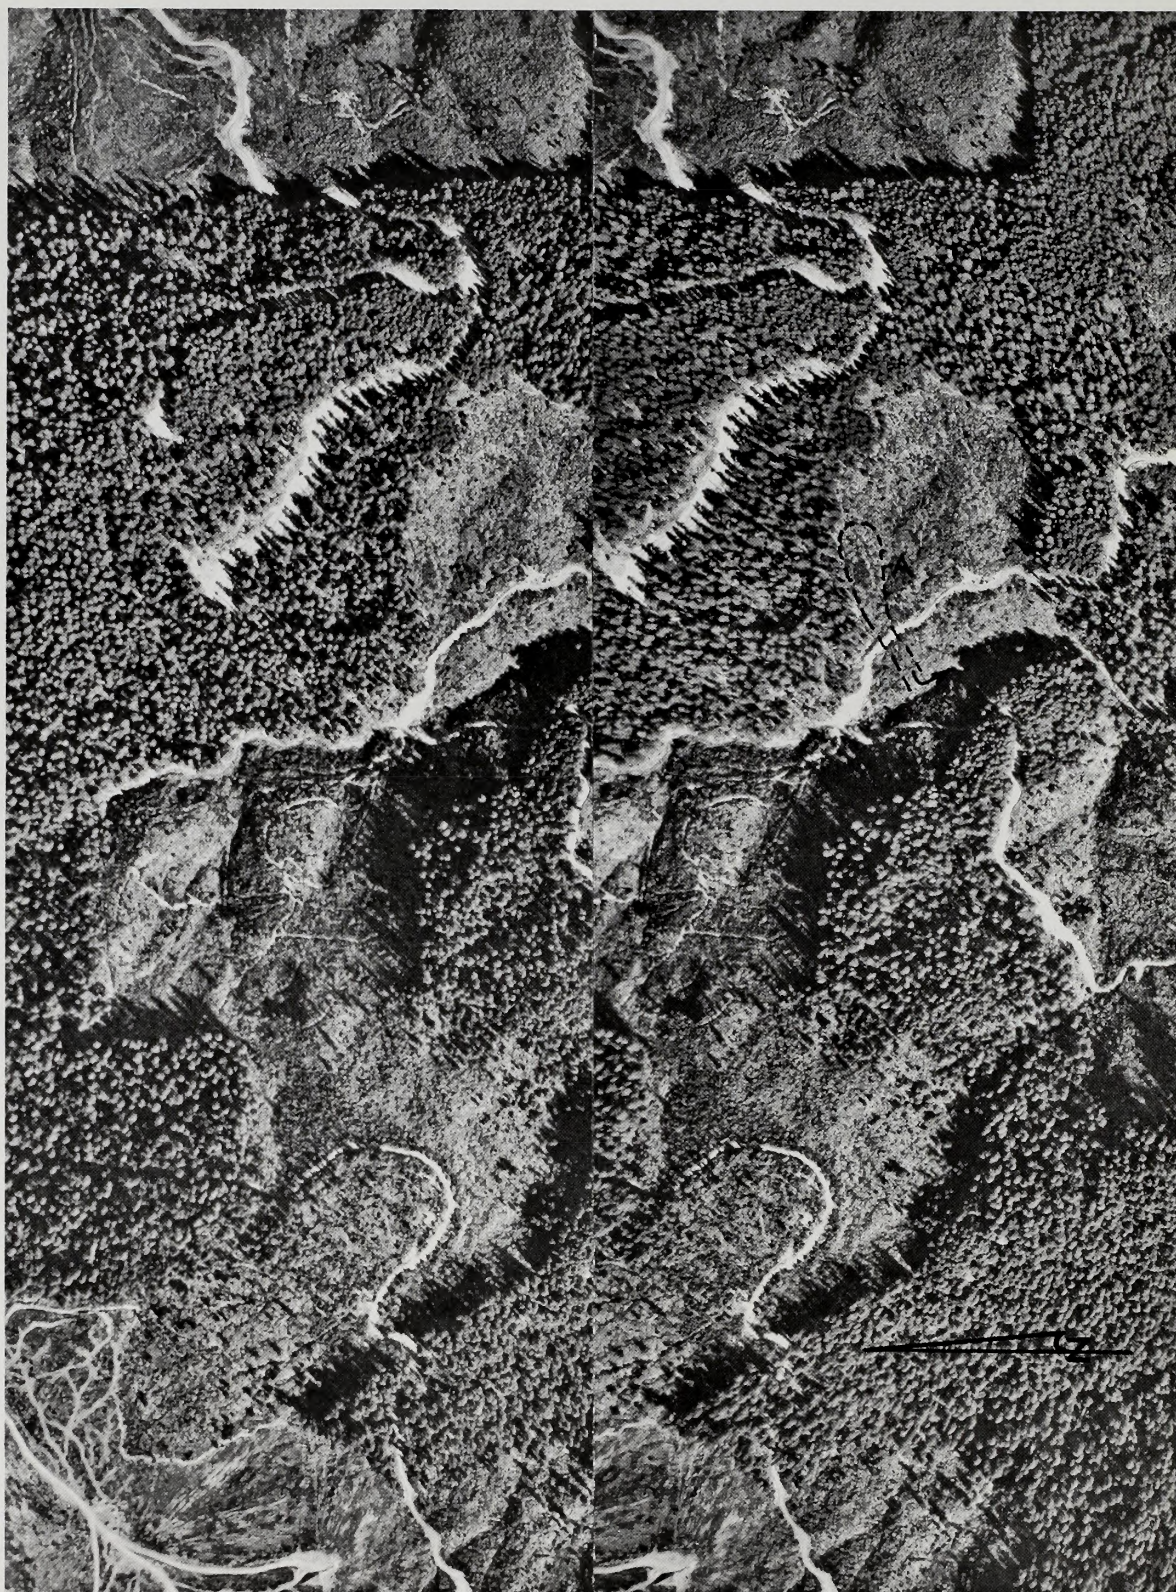
Figure 84. This stereogram shows unstable terrain derived from pyroclastic rock; there is evidence of active soil movement over the entire photo. An old slump is shown at point A and the dashed line outlines a new slump. Figure 85 shows a ground photo of this slump.

Whitcomb Creek, which flows into Green Peter Reservoir on the Middle Santiam River, is an excellent example of unstable terrain associated with pyroclastic rock. Figure 84 (page 62) is a stereogram that shows an old slump at A.

A depression can be seen at the base of the scarp above and to the left of point A. Whitcomb Creek has steepened the slope below this old slump and excavation for the road has removed even more support. This basin failed by slumping after these photos were taken and debris flowed into the creek. The approximate boundary of the new slump is shown on the stereogram. Damage to Whitcomb Creek from the debris flow down the channel was reported to be severe. Figure 85 shows a portion of the new slump and the presence of ground water at the head of the slump is shown by the dark stain on the exposed bedrock.

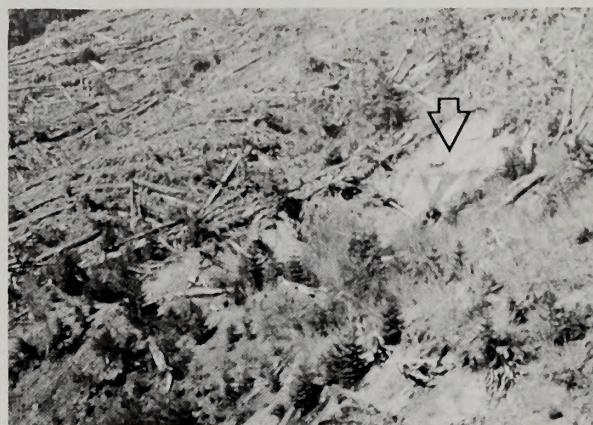
Figure 85. Ground photo of the new slump outlined in Figure 84. The arrow indicates ground water seeping from the face of the scarp.

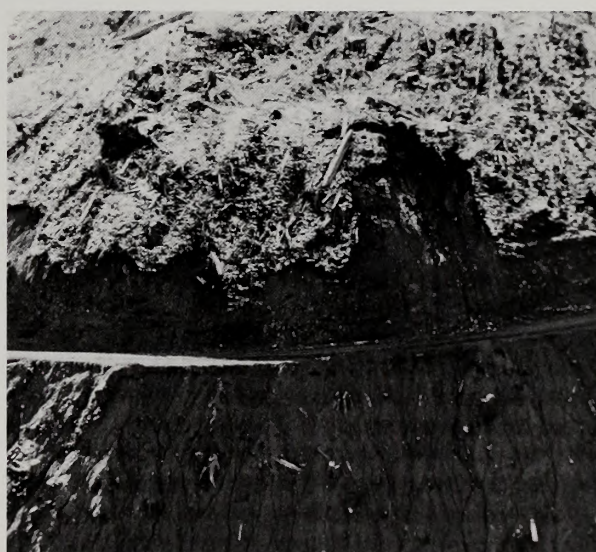
Figure 87. Photograph of the same road in January. Note the progressive failure of the slope above the road.

Use Benches. Benches on hummocky terrain may provide a relatively stable location provided the road width is reduced so that cut bank height will be an absolute minimum. Figures 86 and 87 show a wide road located on a steep sidehill midway between the stream and a bench. Figure 86 was taken in October and Figure 87 was taken

the following January. These figures show that the cut slope is failing and the slump is progressing upward toward the edge of the bench.

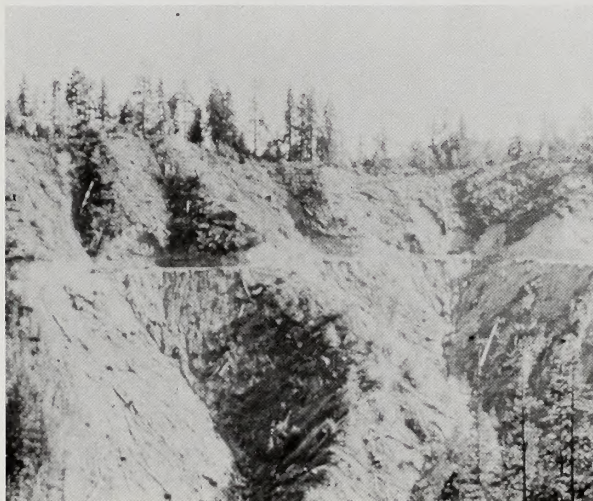
Figure 88. This shows the steep, sharply dissected slopes which are typical of much granitic material.

Granitoid rock is an extremely variable material. Much granitoid rock weathers to a coarse-textured soil that is low in clay. Those soils that develop in place for long periods may have a clay content of as much as 25 percent or more and may be relatively stable. Those soils that are low in clay have a single-grained structure with little cohesive strength that causes them to be easily eroded (Figures 88 and 89). It is these coarse-grained granitic soils that will be considered here.

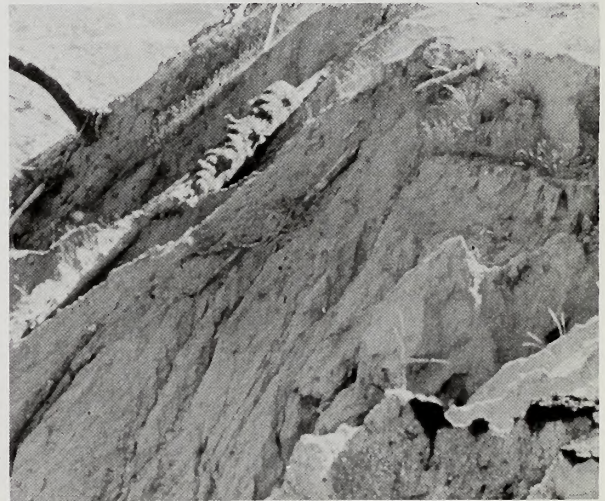
Figure 89. Granitic soils tend to be coarse-grained and very erodible as shown here.

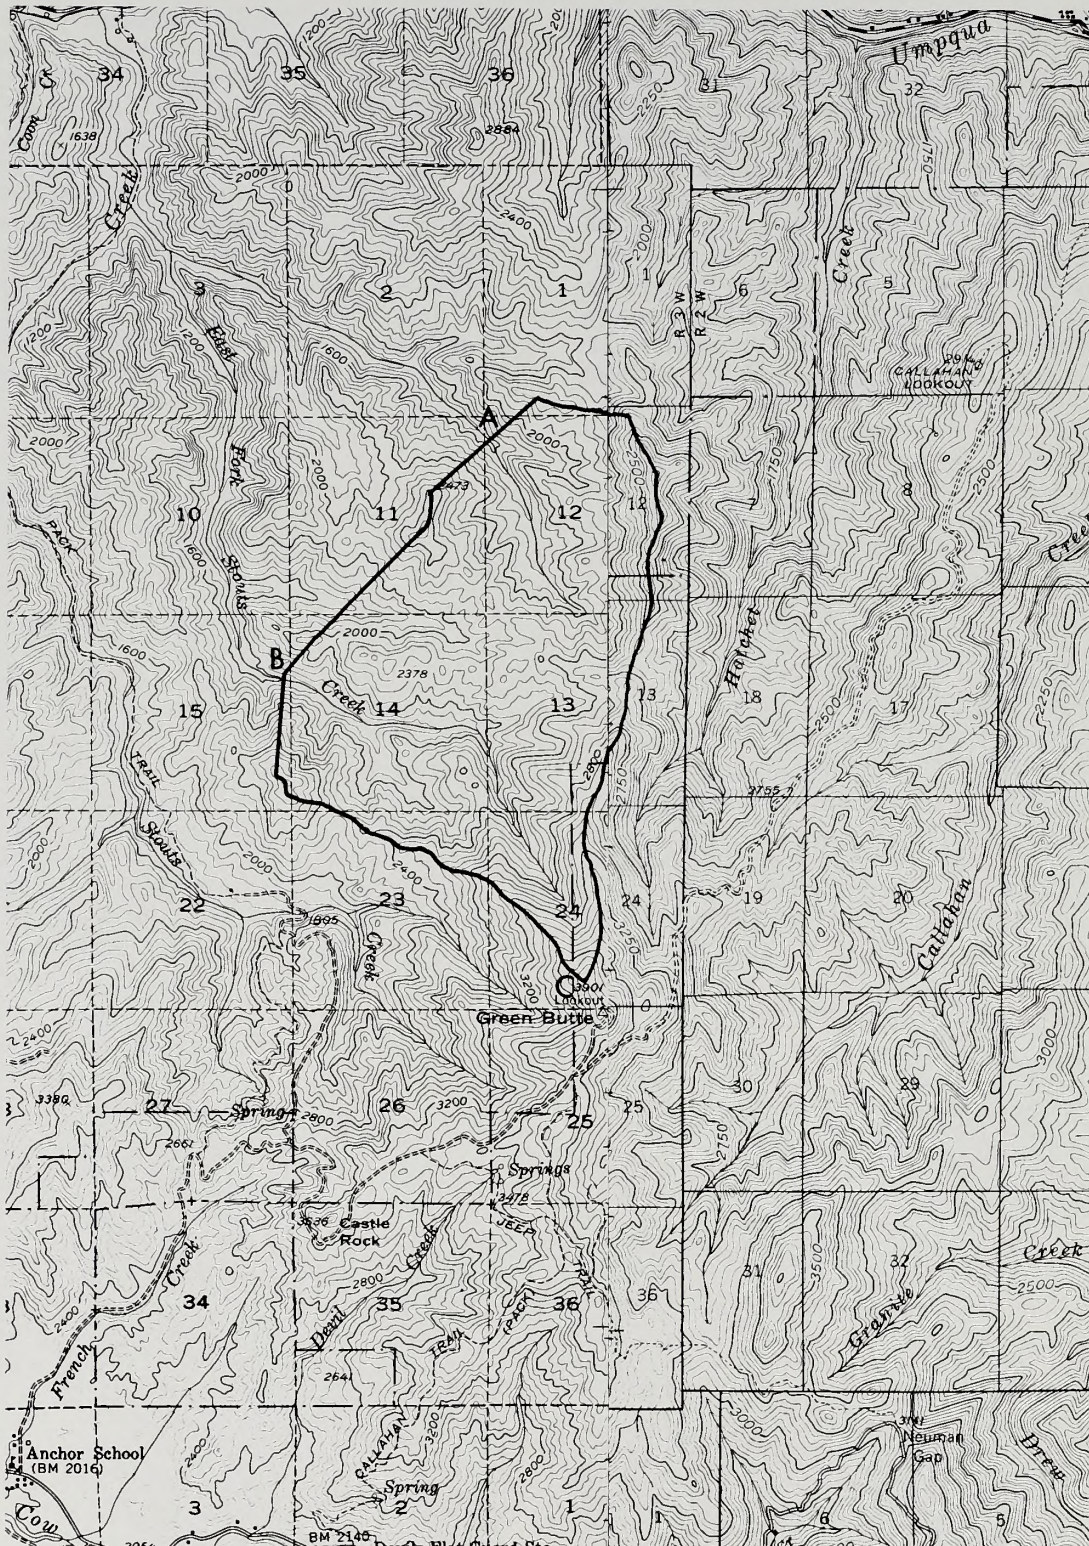
Figure 91. This topographic map was used to develop the block diagram on Figure 90. Points A, B, and C may be used for orientation. The drainage pattern is characteristic of these steep, easily eroded slopes. Debris avalanches are most common on steep slopes, but slumps may occur in deeply weathered material.

The nature of the topography that is typical of deeply weathered, rapidly eroded granitoid bedrock is shown in the block diagram of Figure 90. This topography is from the East Fork of Stouts Creek, a tributary of the South Umpqua River south of Milo, Oregon. Note the steep, highly dissected slopes and the sharp ridges in the block diagram and the characteristic pattern of the contour lines on the topographic map (Figure 91).

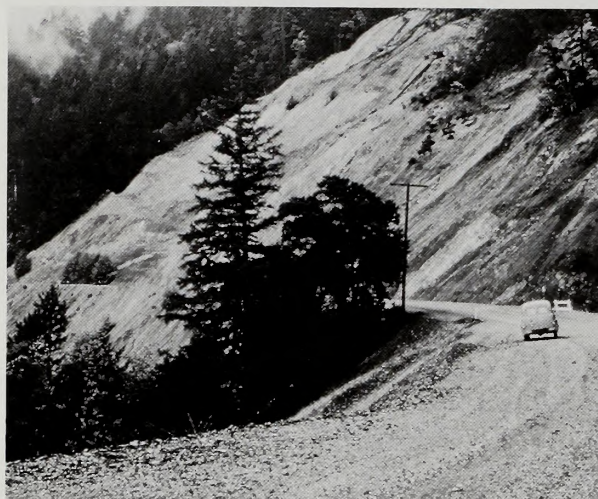
Figure 92. Construction of a road under a mass of clayey soils on a steep slope has caused this material to slump into the road.

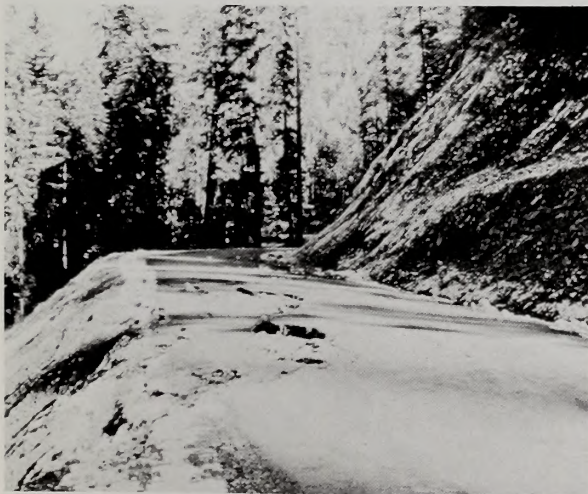
Figure 94. A cracked and sagging road fill in schist material.

Figure 94 shows a sagging road fill and Figure 95 indicates a common cause of road fill failures, both in the schists and in granitoid rocks — impeded ditch drainage as a result of rapidly eroding cut banks. Poor ditch drainage allows water to infiltrate the road prism instead of being carried away. Discharge from culverts can easily erode these soils if the water is allowed to fall on an unprotected fill, as shown in Figure 96. Techniques for road location and construction in the steeper portions of Evans Creek schist are similar to those for the granitoid rocks. For the slumpy, hummocky terrain in the Evans Creek schist use the road location and construction techniques which were suggested for siltstone material under Bedded Sediments, Subsection 3, "Deep Soils Derived from Siltstone," with particular attention to the need for extra culverts.

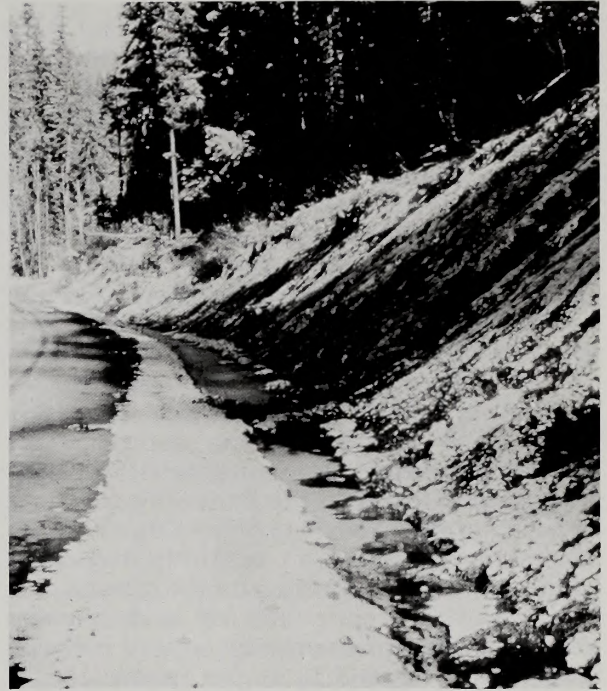
Figure 95. Impeded ditch drainage caused by small slumps.

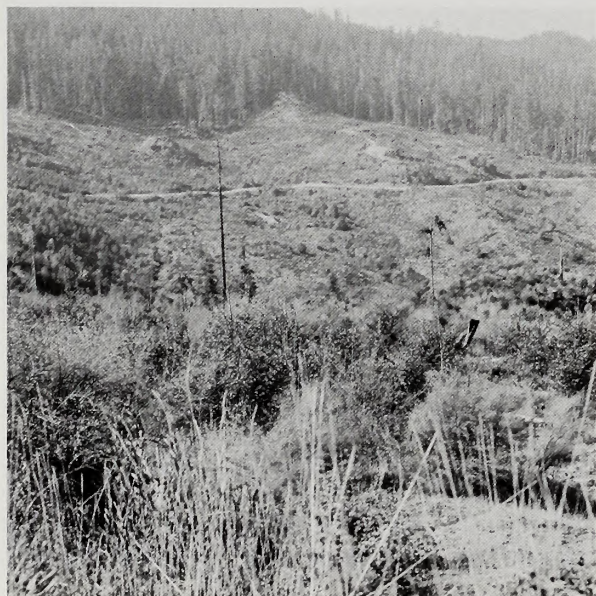
Figure 97. Typical *mélangé* terrain of the Otter Point formation.

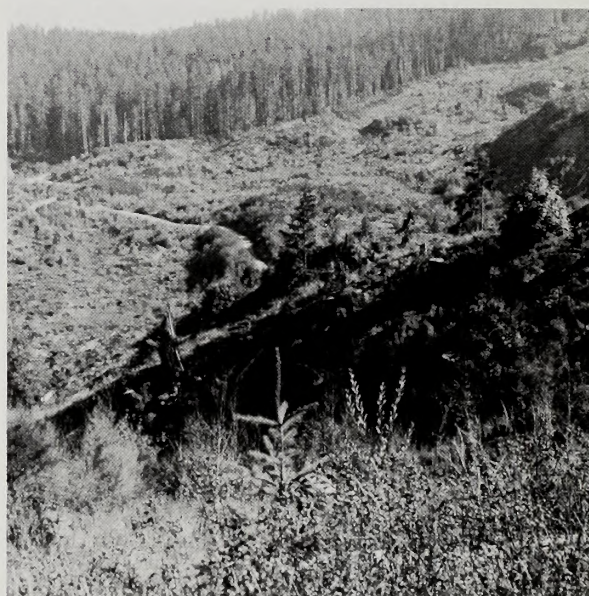
Figure 98. Note the hummocky terrain caused by slumps and earthflows.

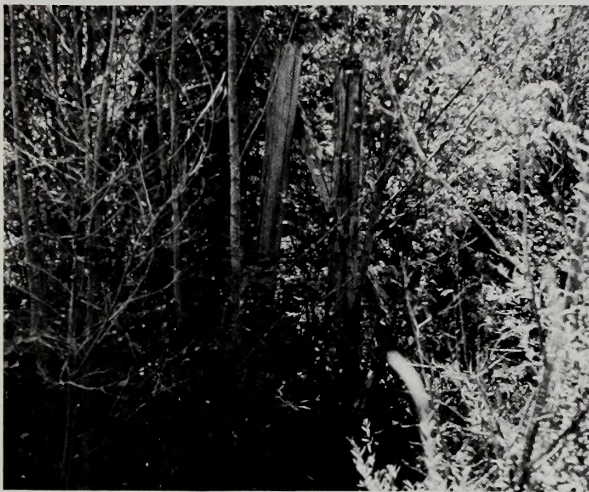
Figure 99. Remains of logging railroad trestle constructed in the late 1920s.

Investigate Piling to Support the Roadway. Timber piling was used extensively in the western United States several decades ago to support logging railways. Figures 99 and 100 show a railroad trestle constructed of Port-Orford-cedar in the early 1920s. Portions of this trestle crossed wet unstable terrain as shown here. These pilings are still upright and do not appear to have shifted significantly. It may be possible to design sections of roadway supported by pilings to traverse those marshes or

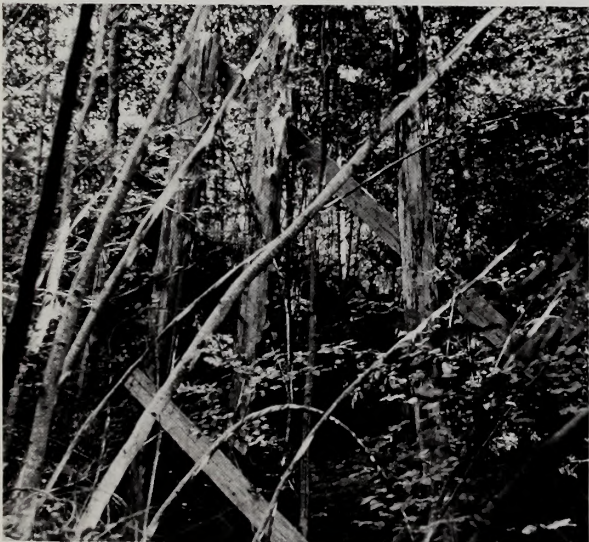
Figure 100. Pilings are of untreated Port-Orford-cedar.

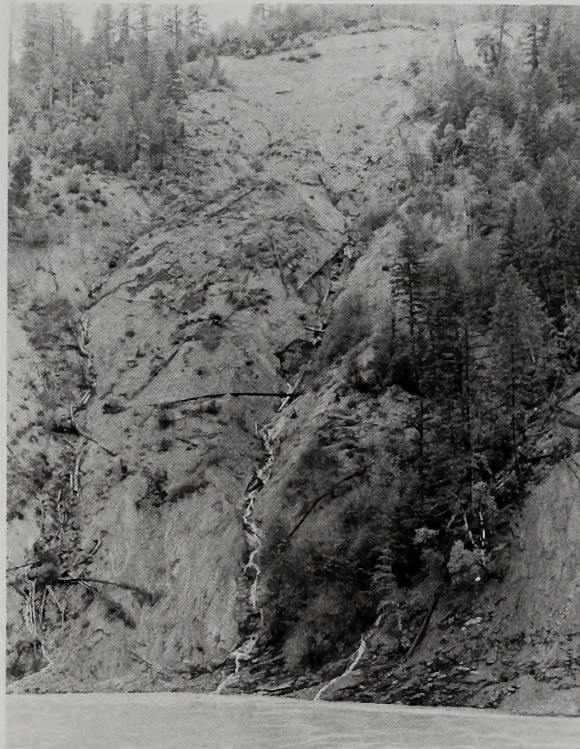
Figure 102. A large natural slide along the Klamath River in northern California. This slide started when the river undercut the slope during the floods of 1964-1965. This slide has progressed until it is threatening the stability of the road shown at the top of the photo. Note the exposed slate just above the water.

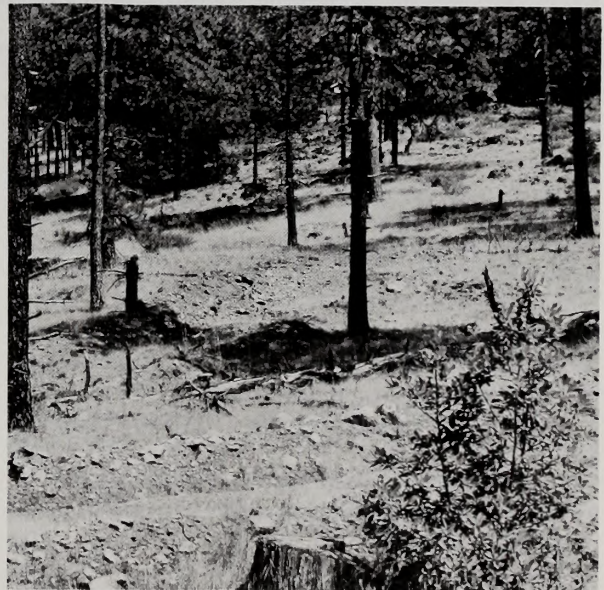
Figure 104. Sparse stands of Jeffrey pine often indicate the presence of serpentine bedrock.

knobcone pine (Franklin and Dyrness). Tolerant shrubs and forbs are pine-mat manzanita (*Arctostaphylos nevadensis*) and beargrass (*Xerophyllum tenax*). Figure 104 shows a typical

hillside of serpentine soils in the drier zone that appears as an open woodland with a sparse growth of grasses and shrubs.

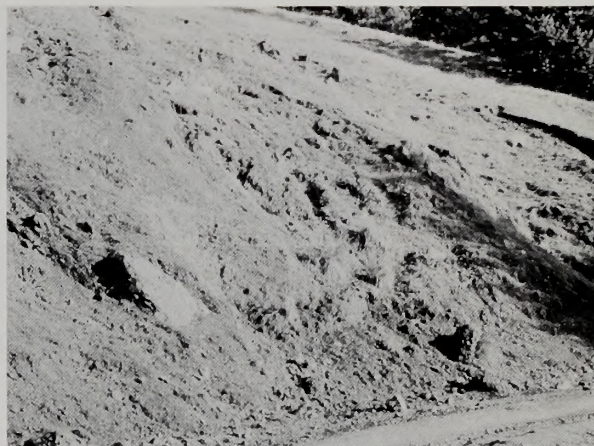
Figure 108. Another glade in serpentine material. Roads cut through these steeper hillsides often develop slumps which gradually become larger unless support and drainage are provided.

hillside covered with conifers (Figures 107 and 108). Stable and unstable glades may be differentiated on aerial photos using the technique described in the section on the Dothan-Franciscan Formation. In addition, a ground reconnaissance will show that very small

unstable glades will show small slips, tension cracks and cat steps (Figures 107 and 108). Rock riprap for support of the cut bank and control of drainage water may be the only slope stabilization techniques that are possible when roads traverse small areas with serpentine soils.

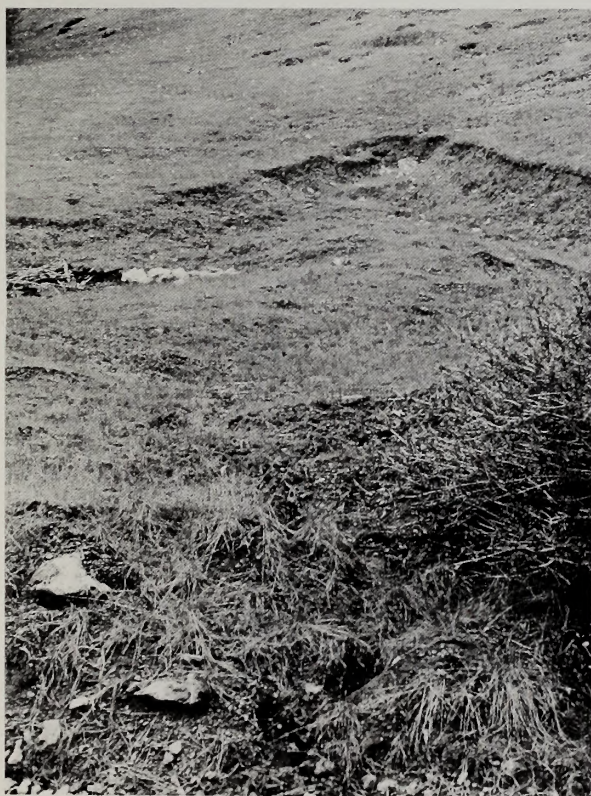
Figure 107. A glade in serpentine material. Note the small seep at the edge of the road at the bottom of the photo and the small slumps on the hillside.

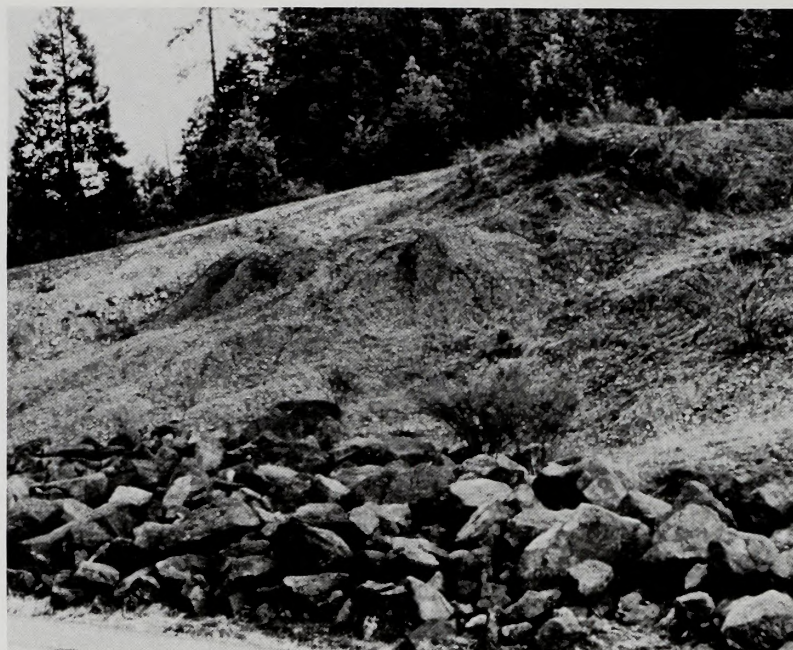
Figure 109. Heavy riprap may be used to support slumping embankments in serpentine material.

Embankment Support. Be prepared to apply buttresses of heavy riprap rock for slumping cut banks (Figure 109).

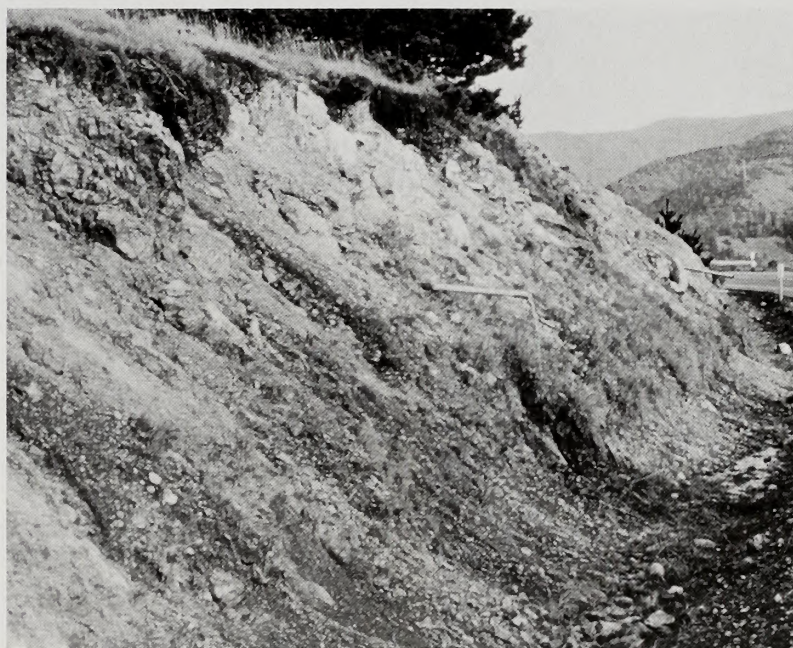
Figure 110. Perforated pipe may be needed to remove ground water from embankments in serpentine. Note the volume of water issuing from the pipe at the right of center.

Ground Water Drainage. Be prepared to collect and dispose of ground water through extra drainage work as the magnitude of the ground water problems become evident as construction begins. This extra work may include perforated pipe in the cut bank (Figure 110).

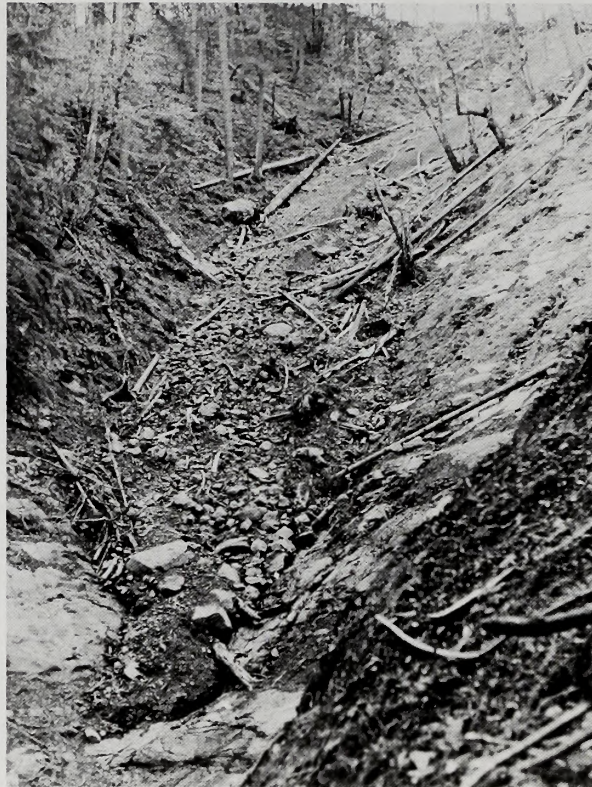
Figure 111. Rubble from road clearance has been deposited in this steep headwall. This increases the potential for another debris slide.

Disposal of debris from avalanches or slumps that falls into the road is a serious problem. Disposal sites which will safely support rock and soil may be a long distance from the slope failure. Nevertheless, such safe disposal sites should be sought out and used. Never take the expedient approach and dump soil, rocks, and debris into drainages or any other location where this material will increase the potential for slope failure. Figure 111 shows the result of a debris avalanche in a steep headwall in Tyee sandstone. The rubble, which extends from the lower part of the photo to the road which circles the top of the headwall, is a result of disposal of debris from cut bank failures elsewhere along the road. In this case, the headwall is primed for another destructive debris avalanche — all it needs is a series of heavy winter rains to raise the ground water level.

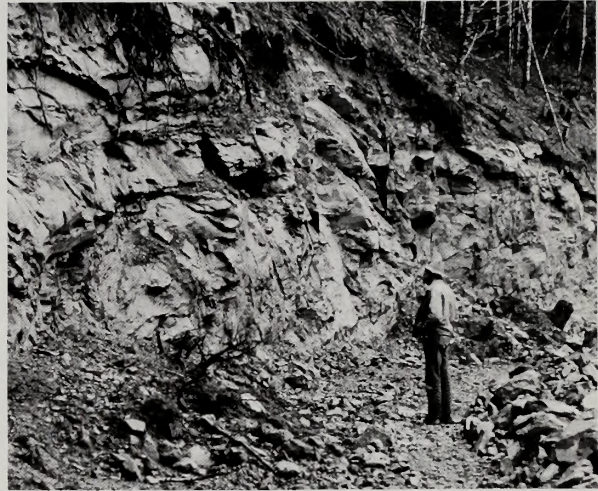
Figure 1. This shows the overbreak caused by random drilling and excessive charges. Note the very shallow soil mantle.

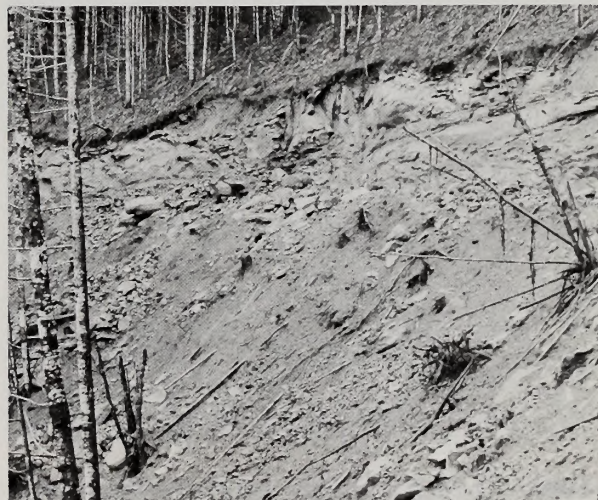
Figure 2. This photo was taken in the same area as Figure 1. It shows the results of overloading the production holes and the consequent sidecasting of excavated material. This sidecast material has destroyed valuable young Douglas fir and created a severe erosion and landslide hazard.

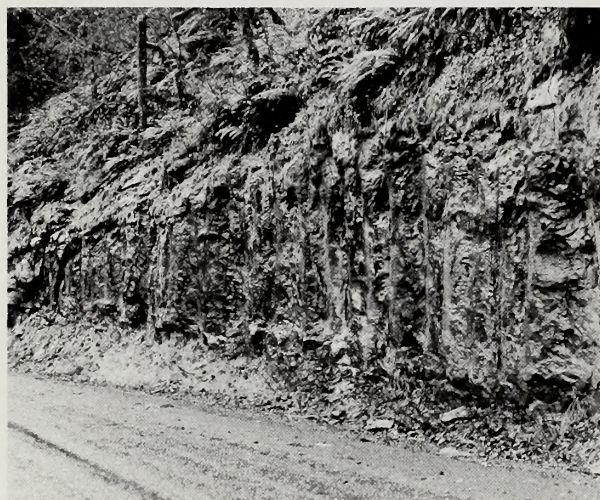
Figure 3. A pre-split cut slope. The drilling pattern was in-line with a 36-inch hole spacing. Each hole was loaded. The result is a relatively smooth cut slope with a minimum amount of sidecast.

Pre-splitting basically is used to 1) produce a neat smooth backslope, 2) prevent overbreakage beyond the neat excavation lines and therefore reduce the amount of material that must be removed, and 3) prevent the shock force of the main blast from disturbing the material beyond the neat excavation lines, thus producing a more stable cut slope (Figure 3).
